# MACHINE SERVICE BULLETIN NO. 244

SUBJECT: LA 6-200-C Model

DATE: December 30, 1935

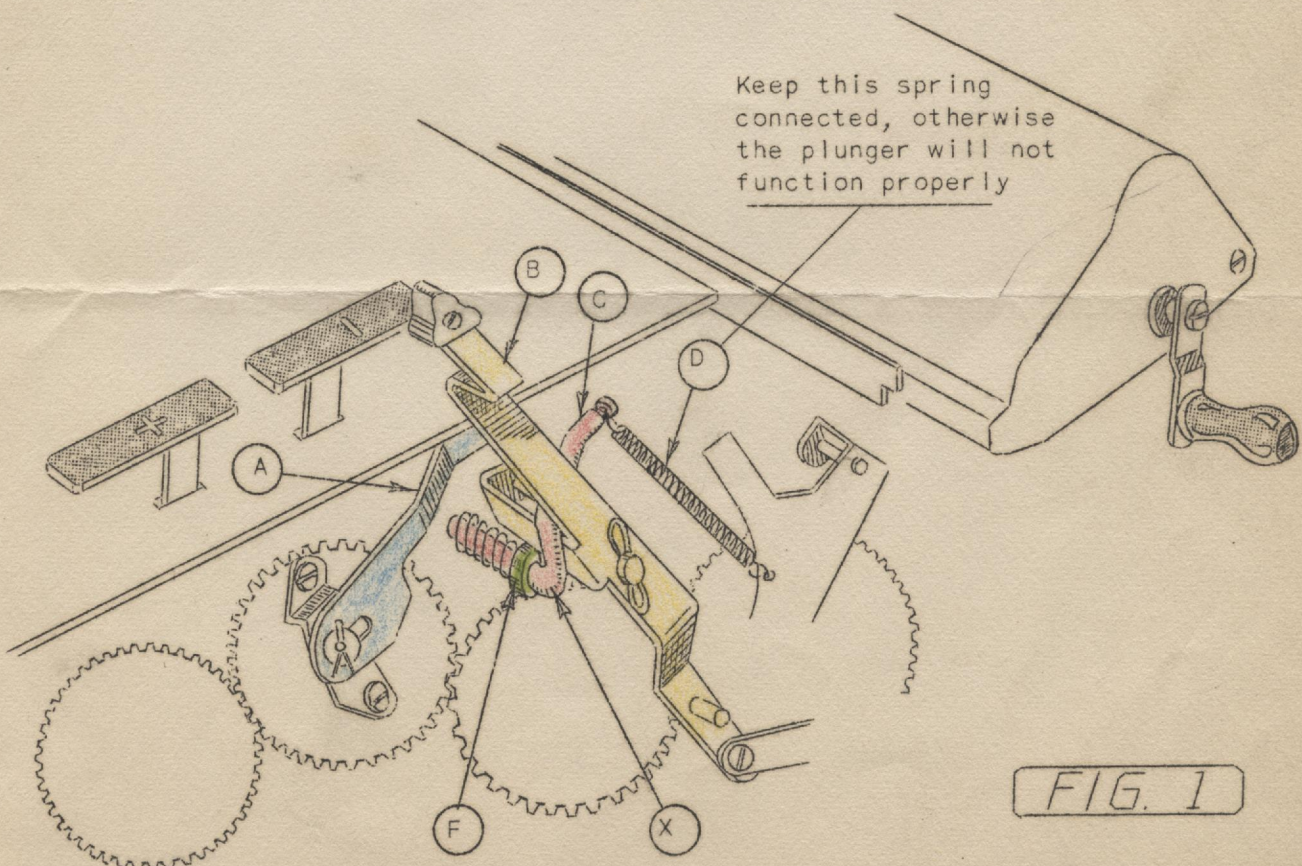
FIG. 1

1. Stock has been removed from the 49070 counting finger (A) to avoid interference with the movement of the 47900 plunger rod. Figure 1
2. If, after the trip lever (K) and the 41-776 guide bracket (Z) have been adjusted the plunger rod (J) should strike the inner side of the 41-777x1 trip lever (K) instead of positioning over it as shown in Figure 3, remove stock from the top of lug (L) to suit,

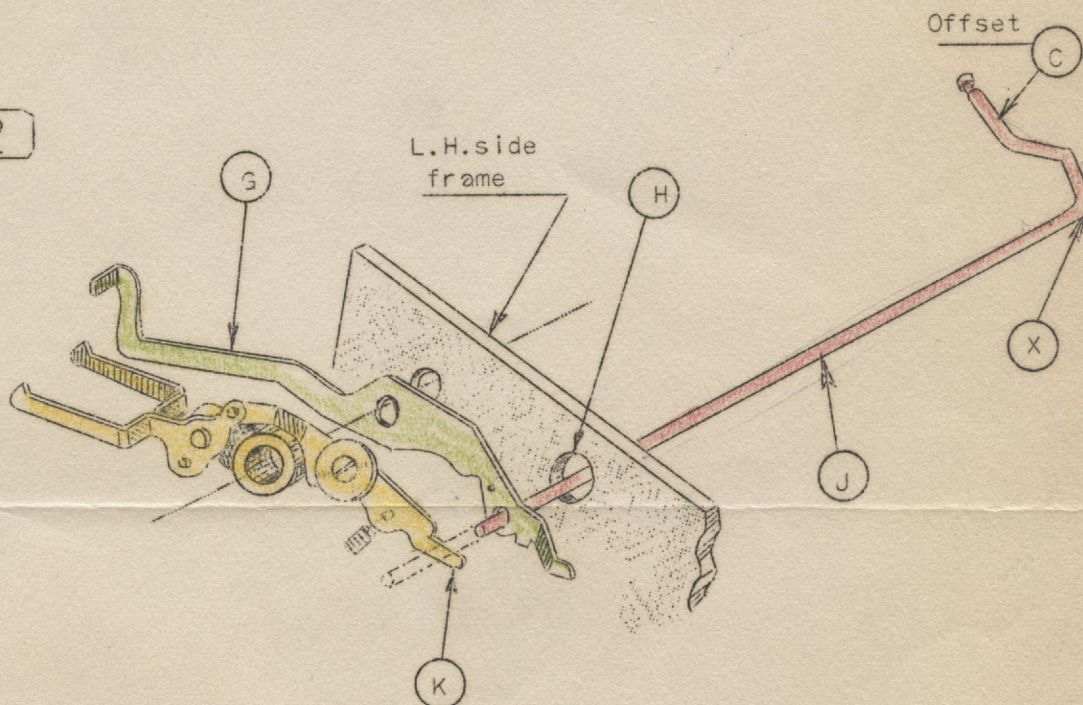
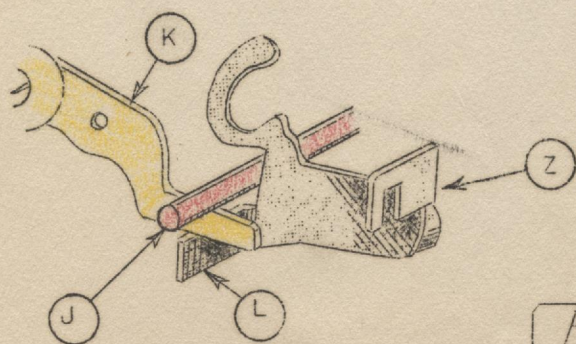
FIG. 2

3. If the plunger rod (J) does not withdraw from engagement with the trip lever (K) when the multiplication lever is positioned toward the rear of the machine, bend the offset (C) of the plunger rod inward at (X).

4. If the plunger rod (J) does not engage the trip lever (K) when the multiplication lever is in neutral, bend the offset (C) of the plunger (J) outward at (X).

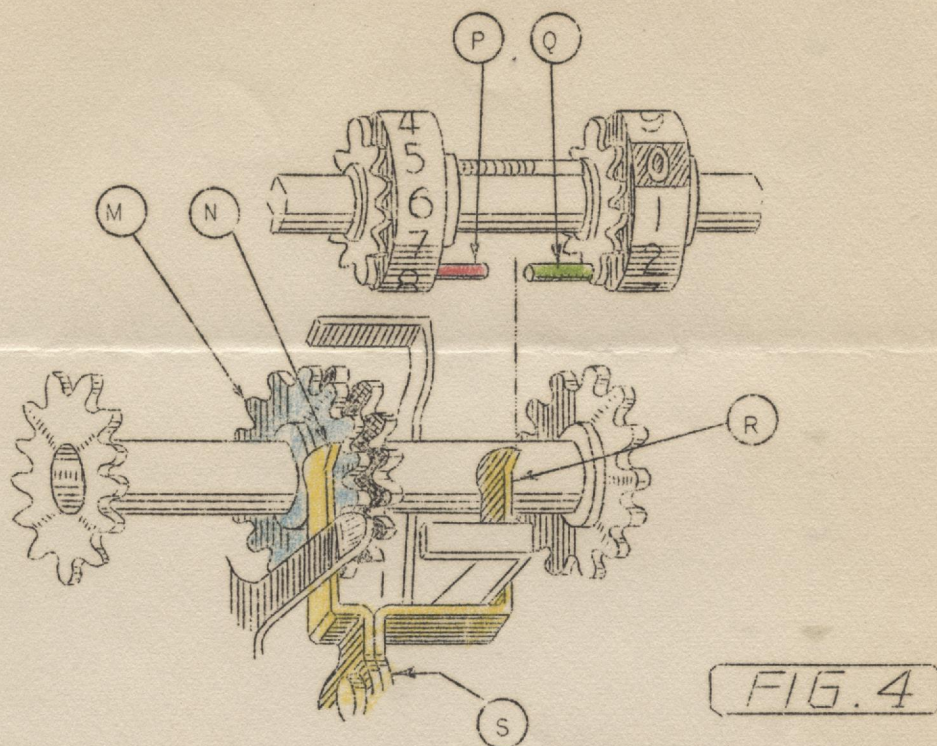
FIG. 3

6. The outer prong (N) of the trip lever (S) should be adjusted as close as possible to the extra carry gear (M) without causing it to bind.
7. Care should be taken that the clearing pins (P) and the 41-527 carrying pins (Q) do not interfere with lug (R).
